Add-On “Last Chance Filter“ for the Solar T-62T-32 Lubrication System

The Solar T-62T-32 160hp turboshaft engine is often selected by aviators for their homebuilt airplanes and helicopters. The engine itself is reliable, forgiving design with a few but livable shortcomings if they are taken care of.

One of these potentially dangerous flaws is the absence of a last-chance-filter in the engine's lubrication system.

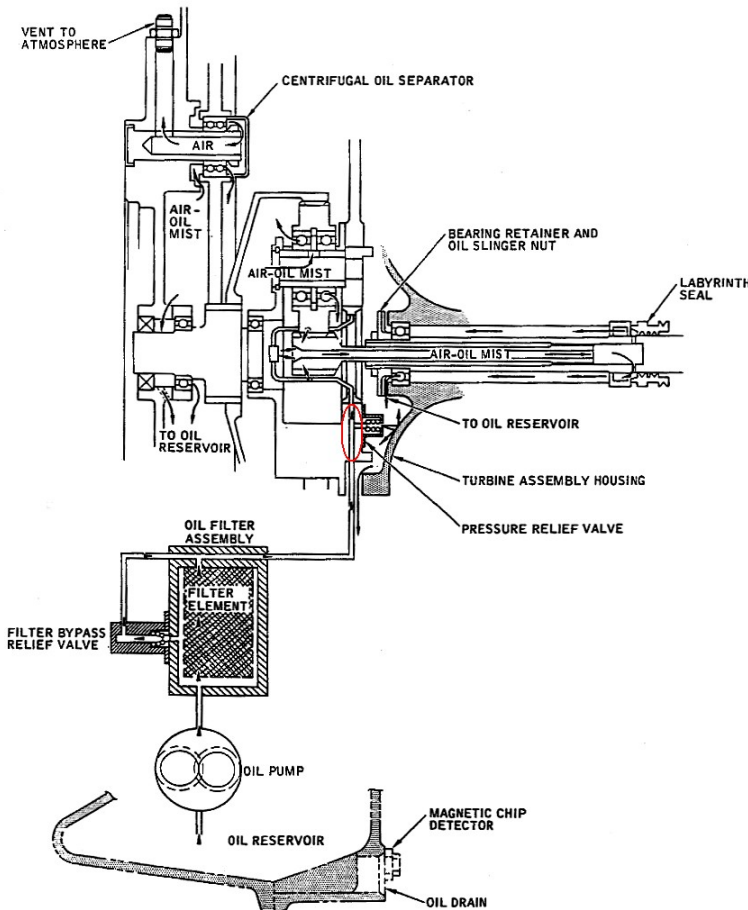
Oil is pumped from the sump by a gear pump through a gallery in the gearbox casing to the oil filter cavity that's also part of the cast gearbox casing. Oil flows through the filter element from outside to inside and is ducted by the machined filter cover to the filter downstream channels which are again part of the gearbox casing(s). Here, a fitting for the oil pressure switch is located as well as another pressure tap (which can be used for an oil pressure gauge). After that, the oil is ducted through a hollow spoke of the planetary gear spider to the central lubrication area. On the rear face of the spider, the oil pressure relief valve is located. Excessive oil is ejected to the inner wall of the turbine assembly housing where it is cooled by dissipating its heat to the metal structure. Oil is injected through four orifices to directly lubricate and cool the high-speed machinery. The orifices are radial bores in the three oil transfer pipes around the sun gear and one central nozzle that directs an oil jet into the hollow sun gear/pinion shaft. All four nozzles have a diameter in the range of 0.6~0.7mm.

Since there is no last chance filter present to protect these nozzles, particles that are larger than the nozzle diameter in at least one direction, may (partially) block the nozzles. Especially critical is the central nozzle since this provides lubrication and cooling to the two high-speed bearings of the engine's turbine rotor shaft (revolving at round about 61,000 rpm). Under marginal lubrication conditions, the cylindrical roller bearing located inside compressor impeller hub, is the first component to fail. This results in either a sheared or fractured rotor shaft, a fractured shaft tunnel and as a consequence severe damage to all turbine rotor and stator components. A damage like this is not economically repairable and requires a replacement turbine power head to get the engine back to servicable condition.

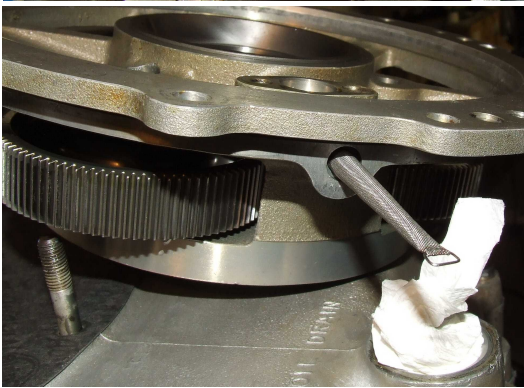
The primary way for dirt to enter the lubrication system is via the oil filter cover. This machined component contains the oil filter bypass valve and closes the circuit from the central oil filter (clean oil) area to the galleries downstream of the oil filter. This cover is inserted into a recess of the gearbox casing and held in place by a circlip. This recessed area is problematic since dirt tends to accumulate there and may even stay after thorough cleaning in the slot of the circlip. Moreover, fragments of the O-ring that seals the cover to the cavity may stay in that area or enter the galleries downstream the oil filter upon re-assembly. Since even very careful and accurate handling of these components will not completely eliminate this threat, we decided to look for options to integrate a last chance filter into the

engine to prevent particles larger than approx. 0.2mm from reaching the oil injection nozzles.

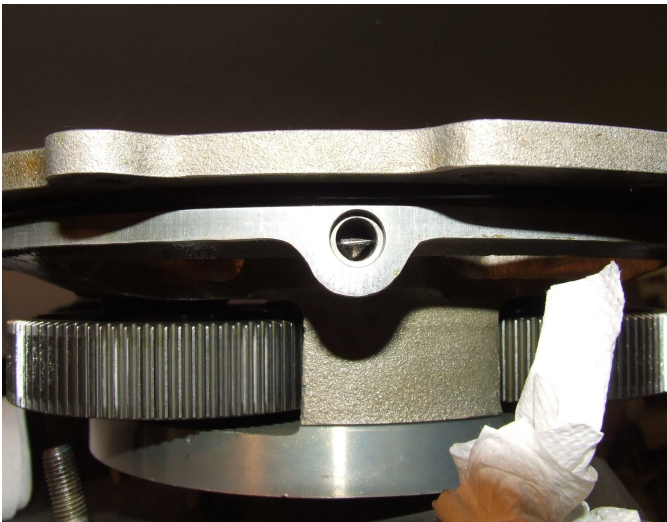
Quickly it was understood that such a filter can be located inside the radial oil passage in the spoke of the planetary gear spider. Since this passage is a machined bore, it is accurate enough to accept a very slim filter element that discharges directly into the annular oil distribution cavity around the pinion. The filter element is specifically produced for that application from stainless steel wire mesh of very fine gauge, rolled into a tapered tube shape and spot welded to a machined base that tightly fits the bore. The seam of the filter is also welded and a pulling eye made of stainless steel wire is attached to the other end. The clearance around the filter is sufficient to permit part of the oil to discharge through the pressure relief valve.

In order to place the last chance filter in the engine, the power head needs to be removed from the engine gearbox and the spider has to be lifted from its seat (by using pry bolts in the threaded holes of the spider body and trying to keep the spider as parallel to the seat as possible during the procedure). When the spider assembly is removed from the engine, it's a good idea to check that the oil passages are clear by injecting WD40 or brake cleaner into the radial orifice. Other than shown in the photos, the oil pressure relief valve should not be removed.
