Add-On “Last Chance Filter“ for the Solar T-62T-32 Lubrication System

The Solar T-62T-32 160hp turboshaft engine is often selected by aviators for their homebuilt airplanes and helicopters. The engine itself is reliable, forgiving design with a few but livable shortcomings if they are taken care of.

One of these potentially dangerous flaws is the absence of a last-chance-filter in the engine's lubrication system.

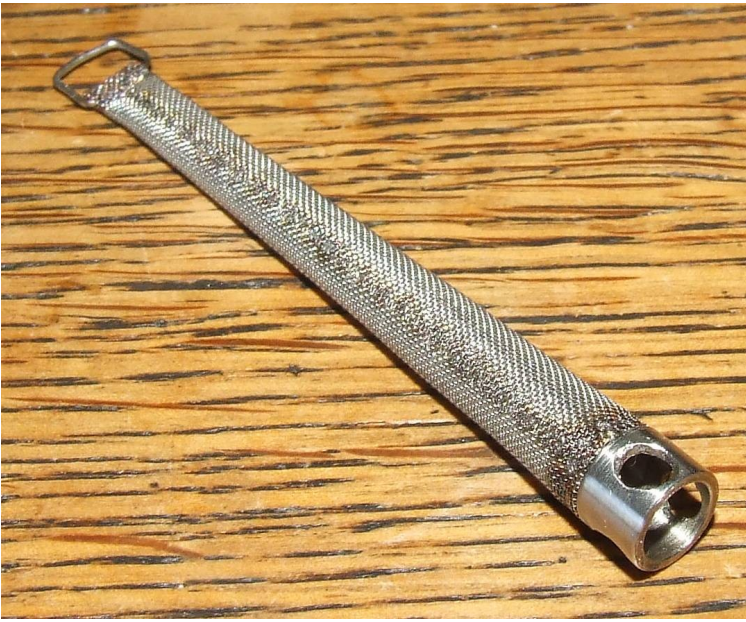
During our occupation with a stock T-32 engine to be put into an Ultraspport 496 turbine conversion, this actually led to a catastrophic failure of the roller bearing and damage to the “power head“ of that particular engine beyond repair (yet without high-energy debris being released from the engine).

Since there is no last chance filter present to protect these nozzles, particles that are larger than the nozzle diameter in at least one direction, may (partially) block the nozzles. Especially critical is the central nozzle since this provides lubrication and cooling to the two high-speed bearings of the engine's turbine rotor shaft (revolving at round about 61,000 rpm). Under marginal lubrication conditions, the cylindrical roller bearing located inside compressor impeller hub, is the first component to fail. This results in either a sheared or fractured rotor shaft, a fractured shaft tunnel and as a consequence severe damage to all turbine rotor and stator components. A damage like this is not economically repairable and requires a replacement turbine power head to get the engine back to servicable condition.

Quickly it was understood that such a filter can be located inside the radial oil passage in the spoke of the planetary gear spider. Since this passage is a machined bore, it is accurate enough to accept a very slim filter element that discharges directly into the annular oil distribution cavity around the pinion. The filter element is specifically produced for that application from stainless steel wire mesh of very fine gauge, rolled into a tapered tube shape and spot welded to a machined base that tightly fits the bore. The seam of the filter is also welded and a pulling eye made of stainless steel wire is attached to the other end. The clearance around the filter is sufficient to permit part of the oil to discharge through the pressure relief valve.

After all oil nozzles are found to be clear (or have been properly cleaned), the LCF element is inserted as shown into the bore as far as it will go. The

With this filter in place, the risk of an engine failure due to dirt bypassing the oil filter or otherwise finding its way into the galleries downstream the oil filter is virtually eliminated.
